**Re: Phase I Building Enclosure Investigation
Stuart-Hobson Middle School
Washington, DC
Walter P Moore Project No. D01.16016.00**

**STUART-HOBSON MIDDLE SCHOOL
PHASE I BUILDING ENCLOSURE
INVESTIGATION**

401 E St NE
Washington, DC 20002

Report Date	September 29, 2016
Façade System (Auditorium)	Brick Mass Wall
WPM Project No.	D01.16016.00

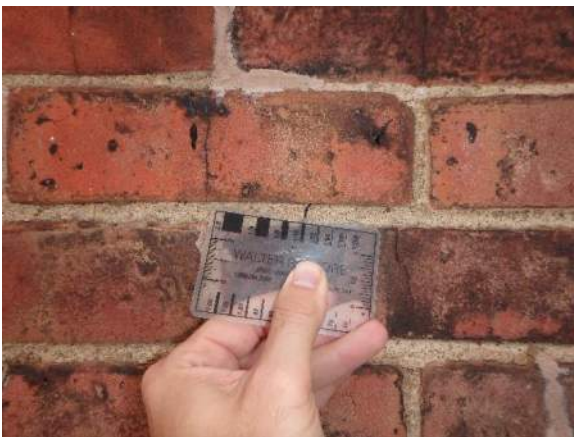
1. Cracks/voids in mortar joints (Photos 3 and 4). **Note:** Crack widths of up to 1/16" measured.
2. Deteriorated mortar joints.
3. Past mortar joint repairs (Photo 5).
4. Variable mortar joint widths. **Note:** Joint widths of 1/8" (min.) up to 1/2" (max.) measured.
5. Cracks through bricks (Photo 6). **Note:** Crack widths of up to 1/32" measured.
6. Localized stair-step cracks.
7. Localized brick spalls (Photo 7). **Note:** Spalls appear to be the result of freeze-thaw damage.
8. Corrosion at head of windows on west exterior wall (Photo 8).
9. Sealant applied at the joint between the soldier course brick and steel lintel at the head of windows on the west exterior wall (Photo 9).
10. Black staining on brick in certain areas of both the east and west walls (Photo 10).
11. Water leaking out of glass-to-metal gasketed joints in new windows (Photos 11 and 12).

Photo 3: Mortar joint crack.

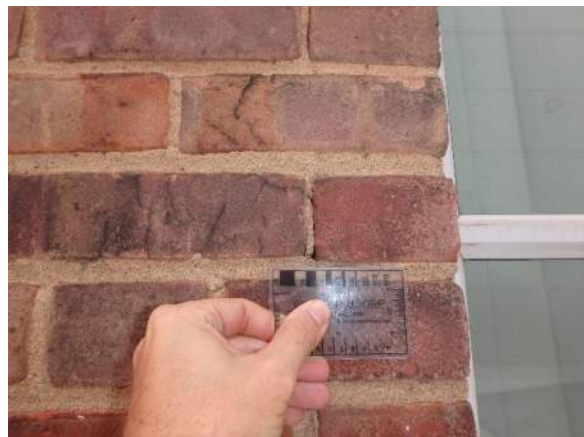
Photo 4: Mortar joint void.

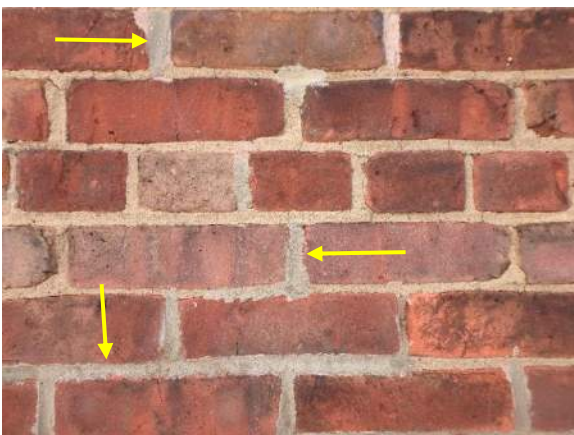
Photo 5: Mortar joint repairs.

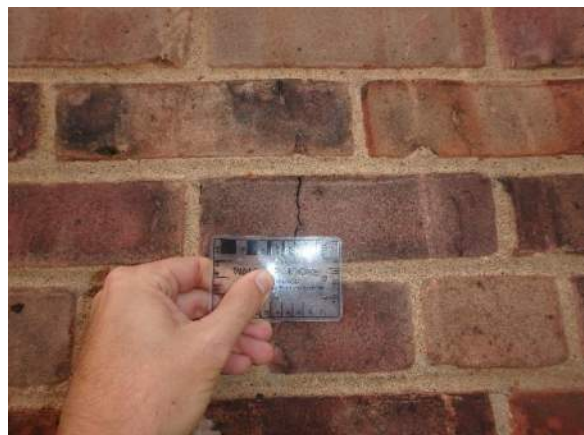
Photo 6: Crack through brick.

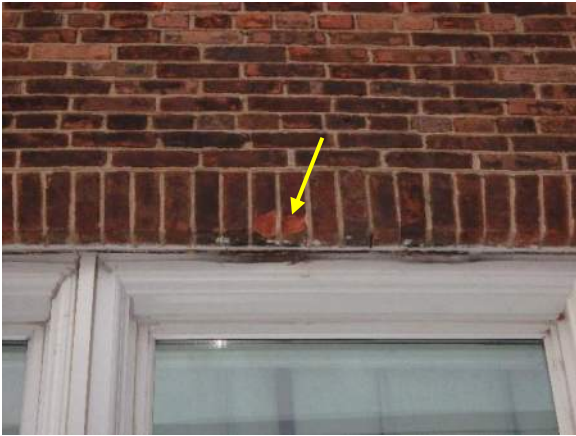
Photo 7: Brick spall above window.

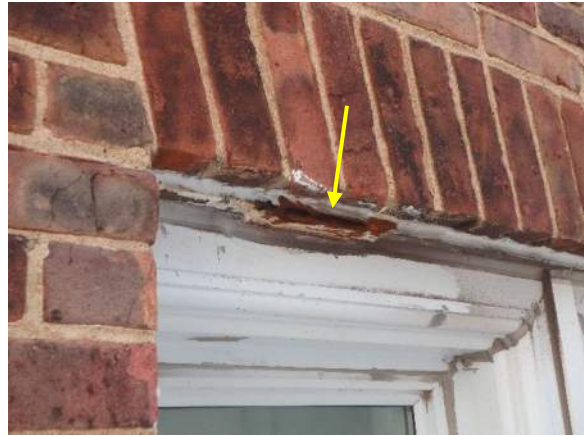
Photo 8: Corrosion at window head.

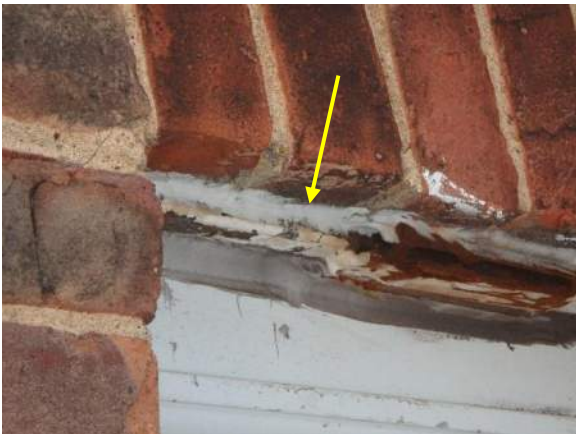
Photo 9: Sealant installed between soldier brick and steel lintel.

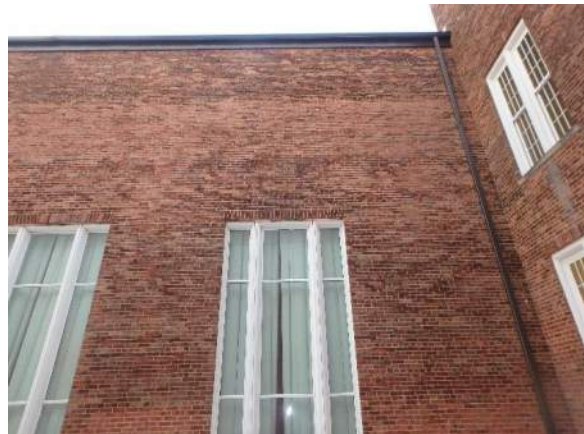
Photo 10: Partial view of west exterior wall of auditorium. Note varying color and staining of brick.

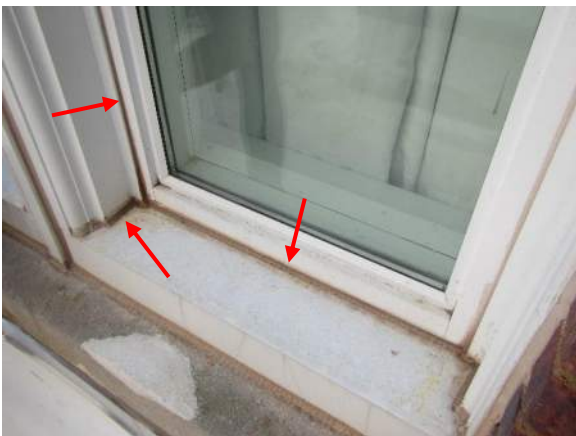
The new windows at the west wall of the auditorium may have also likely contributed to the interior moisture-related distress. Sealants have been installed at metal-to-metal joints/seams in the window frames. These sealants were not installed at the time of window fabrication but were rather installed in the field. Based on our observations of water leaking out of glass-to-metal gasketed joints, it is possible that the drainage system for the windows has been blocked by the field-applied sealants. Window units are typically designed to permit drainage of incidental water and condensation from the assembly. The observed leakage out of the gasketed joints indicates that the drainage system for these windows is not functioning properly. It is also possible that under certain conditions water vapor condenses on the window frame and enters the brick wall, adding to the moisture that has entered the wall due to ingress of mass water through distressed/deteriorated mortar joint and brick units.

Photo 11: Sill of new window at auditorium. Arrows highlight field installed sealants at metal-to-metal joints/seams.

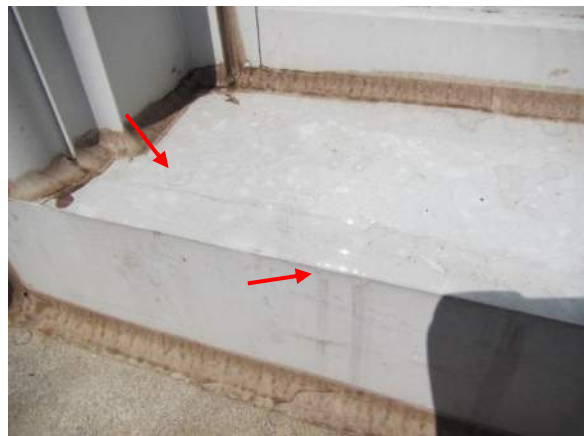
Photo 12: Close-up view of sill/jamb interface. Arrows denote water on sill framing.

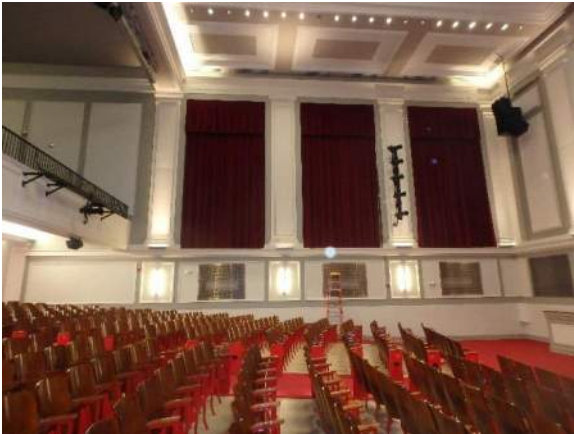
The interior finishes on both the east and west exterior walls (Photos 13 and 14) of the auditorium were observed. In general, moisture-related distress that was widespread on the west wall as absent from the east wall. Accordingly, the observations below pertain to the west wall.

Photo 13: General interior view of west exterior wall of auditorium.

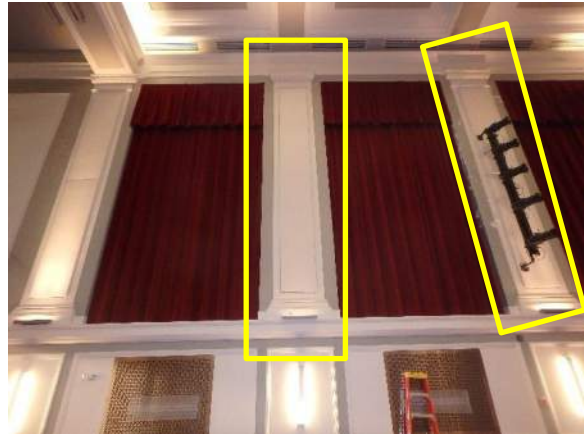
Photo 14: Closer view of windows on west wall. Areas of most prominent moisture-related distress are highlighted.

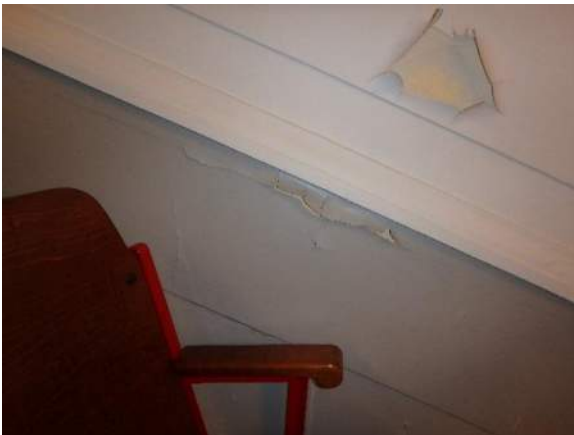
- Cracked paint.
- Blistering/bubbling/peeling paint (Photo 15).
- Deteriorated plaster (Photos 16 – 18).
- Deteriorated decorative gypsum shapes (Photo 19).

Photo 15: Peeling paint at east wall at balcony.

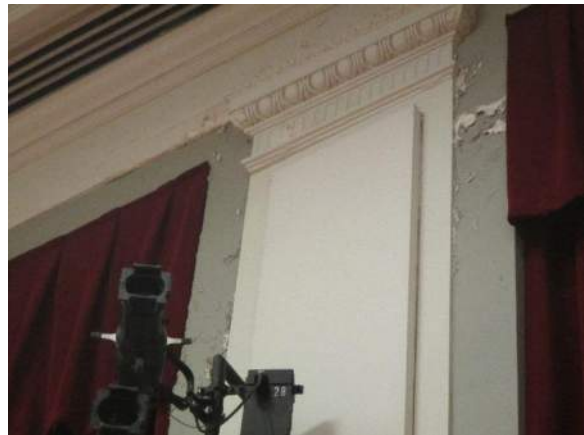
Photo 16: Plaster deterioration between windows.

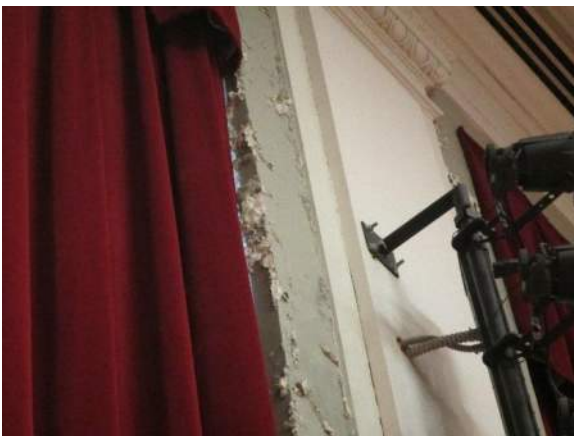
Photo 17: Deterioration of plaster at window jamb.

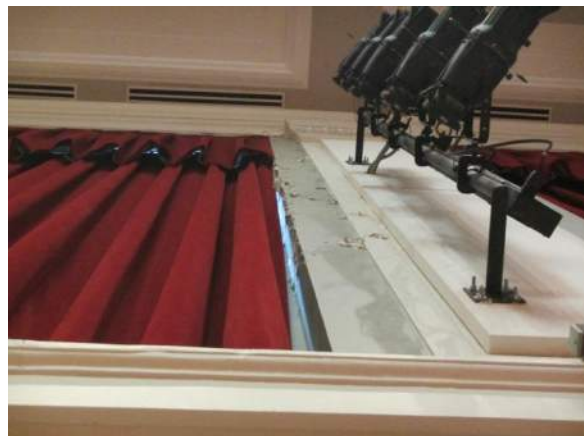
Photo 18: Deterioration of plaster at window jamb.

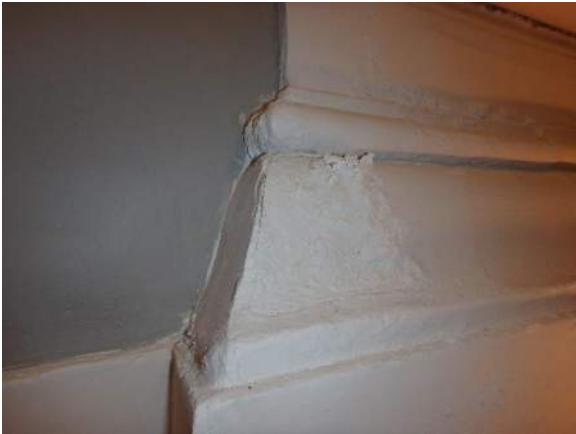
Photo 19: Deterioration of decorative gypsum shape near window sill.

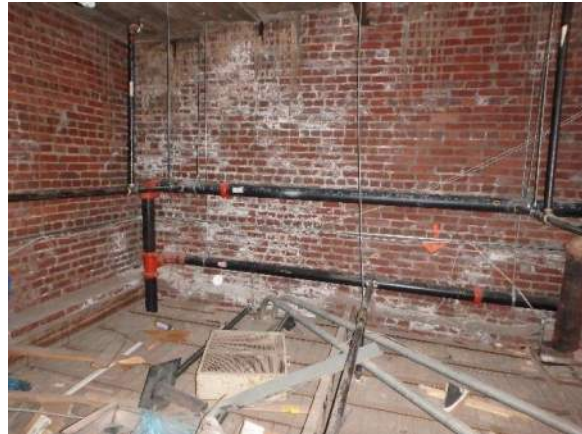
- Efflorescence on interior surfaces of both the north and west exterior walls of the auditorium (Photo 20).

Photo 20: Efflorescence observed inside attic.

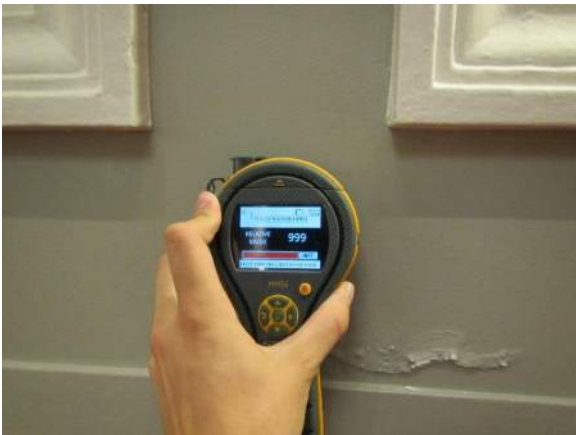
Relative moisture readings were taken on the interior finished surfaces of the east and west walls of the auditorium. Non-destructive readings were taken using a GE Protimeter MMS2 moisture meter which measures moisture on a scale of 0 to 999. Readings were taken over the wall sections located under the windows. Readings taken at the east wall ranged from 129 to 256. Readings taken at the west wall ranged from 139 to 999 (Photo 21). Refer to Exhibits A and B.

Photo 21: Moisture meter reading at west wall.

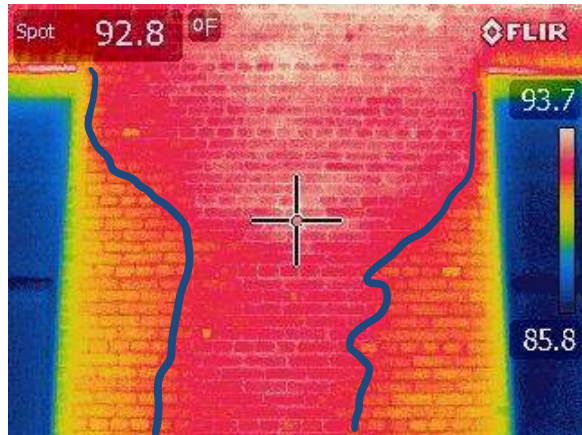
Photo 22: Infrared image of location of west exterior wall. Areas in yellow along window jambs have lower surface temperature than other (red) areas.

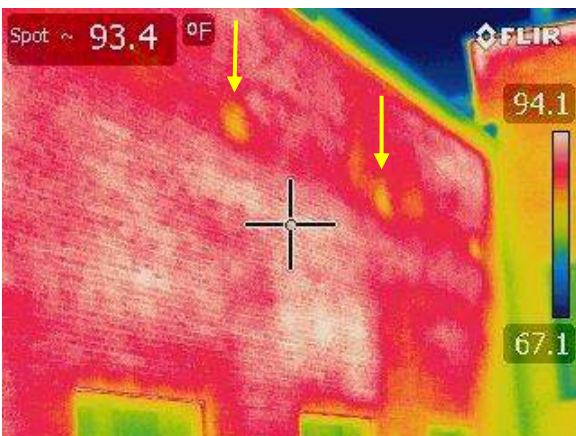
Photo 23 shows large areas of the wall in a magenta color and other areas in a white color. The white color indicates the highest surface temperature detected. The magenta color indicates wall areas with a slightly lower surface temperature. It is feasible that the white color indicates that these areas of the wall are retaining more moisture relative to the areas in the magenta color. Water has a high heat capacity, which is defined as the ratio of the heat added to (or removed from) a material to the resulting temperature change of the material. Accordingly, wet brick will not change in temperature as much as dry brick when heat is added to or removed from the material. With the drop in air temperature and lack of radiant heat at the time the infrared image was taken, heat was being removed from the brick wall. The resulting temperature change of the brick would have been less in areas of the wall with higher moisture content.

Photo 23: Thermal anomalies at west wall.

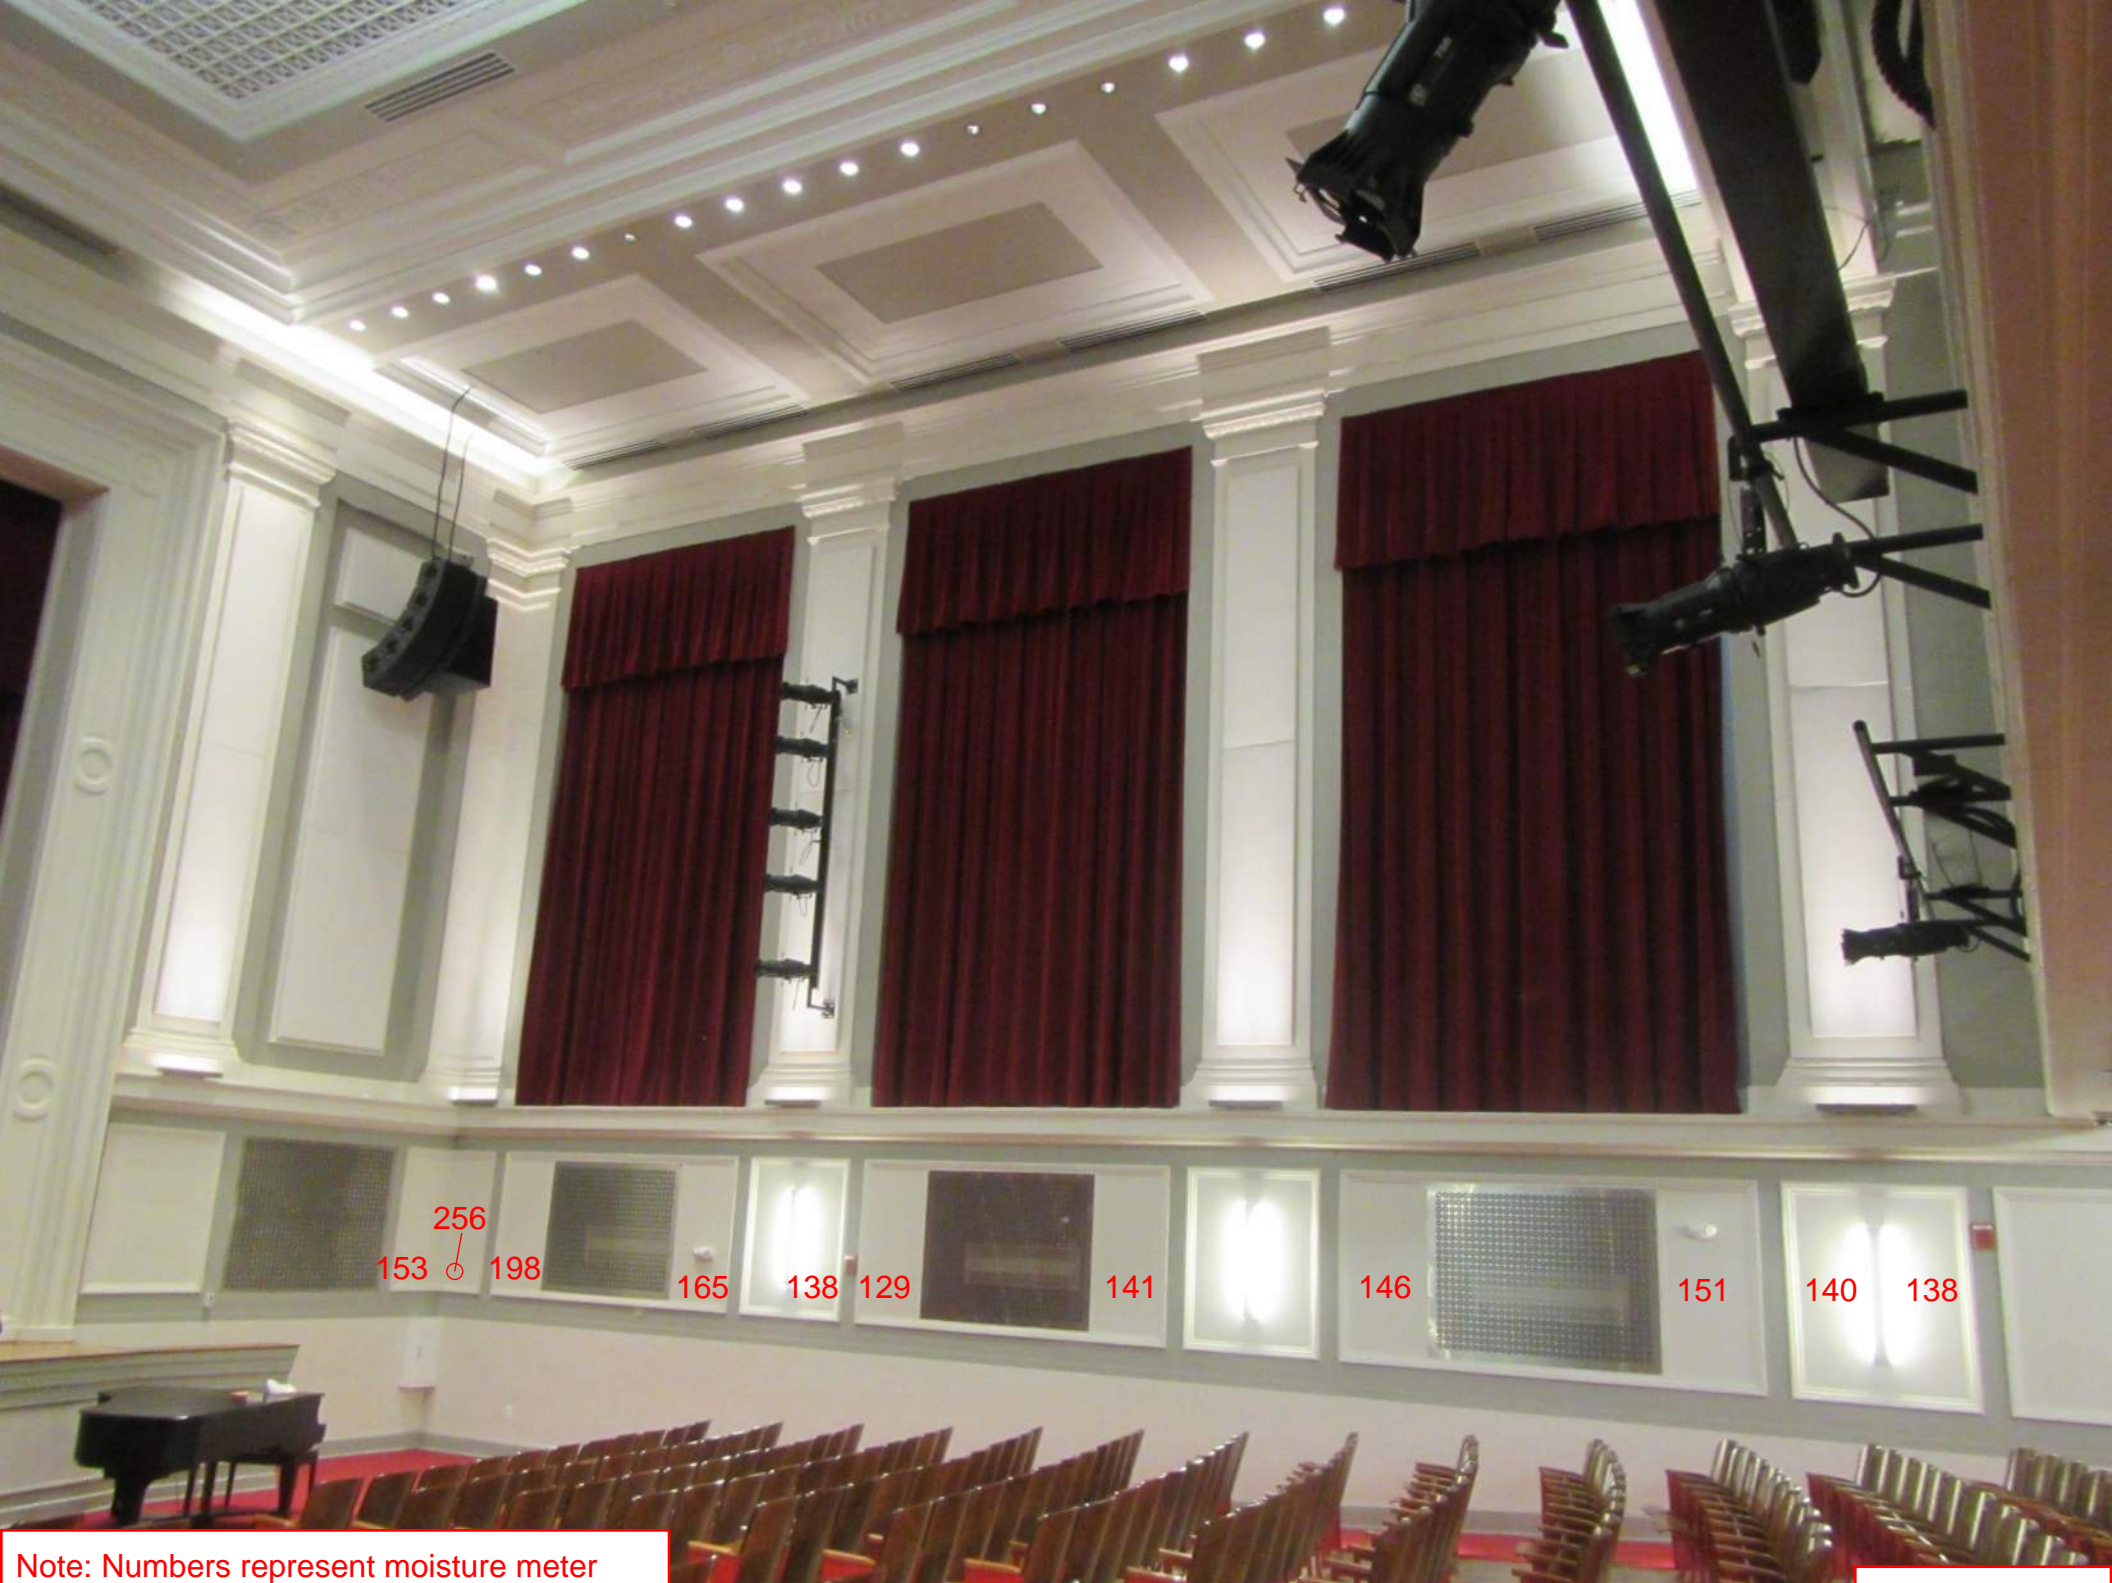
EXHIBIT A

153 256 198 165 138 129 141 146 151 140 138

Note: Numbers represent moisture meter readings taken at east wall of auditorium.
