## INITIAL REPORT

November 3, 2020

**District of Columbia- A Municipal Corporation**  
425 C Street NE, Washington, DC 20002  
Water – Date of Loss: 9/29/20

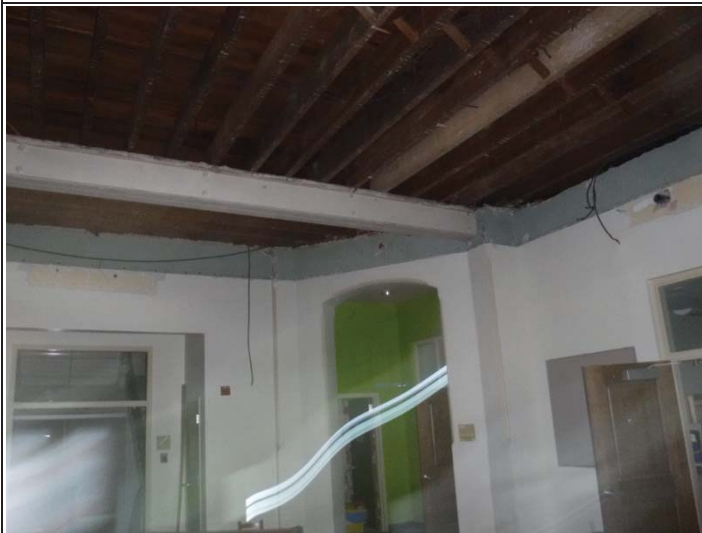
The cause and origin of the loss, as indicated by the Insured's onsite representative, was a broken sprinkler head/line at the 3<sup>rd</sup> Floor ceiling that broke when the lath and plaster ceiling collapsed at the open space hallway located in the center of the building. The broken sprinkler head/line caused water to flow throughout the 3<sup>rd</sup> floor and down to and through Levels 2, 1, and the Basement, causing various degrees of damage. This is consistent with the Silman Report dated 10/1/20 indicating that the collapsed ceiling, which was added during the 1966 renovation, was noted to have undersized hangers.

Subrogation potential may exist due to the under-sizing of the metal lath and plaster ceiling hangers installed as part of the 1966 renovation causing the collapse. Further investigation would likely be required to determine the responsible party for the sizing of the hangers.

Caption #3: Condition of 3<sup>rd</sup> Floor ceiling at Open Area/Hallway

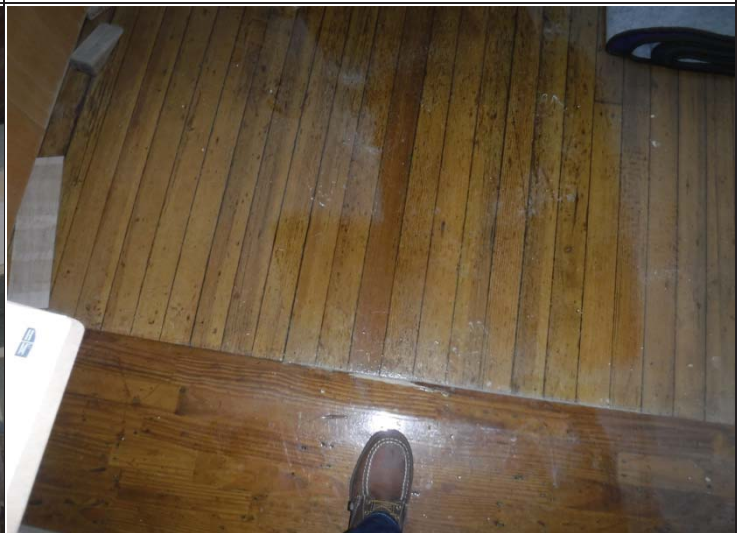
Caption #4: Condition of wood floors at Kindergarten Room.

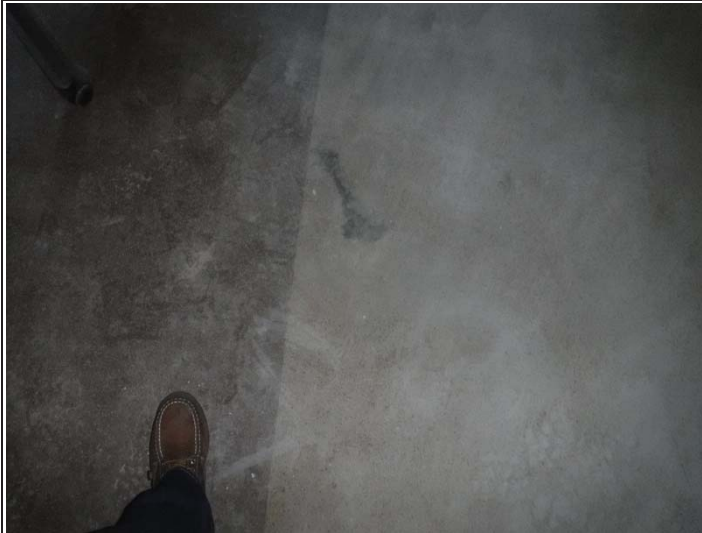
Caption #5: Floor condition at 3<sup>rd</sup> Floor Open Area/Hallway

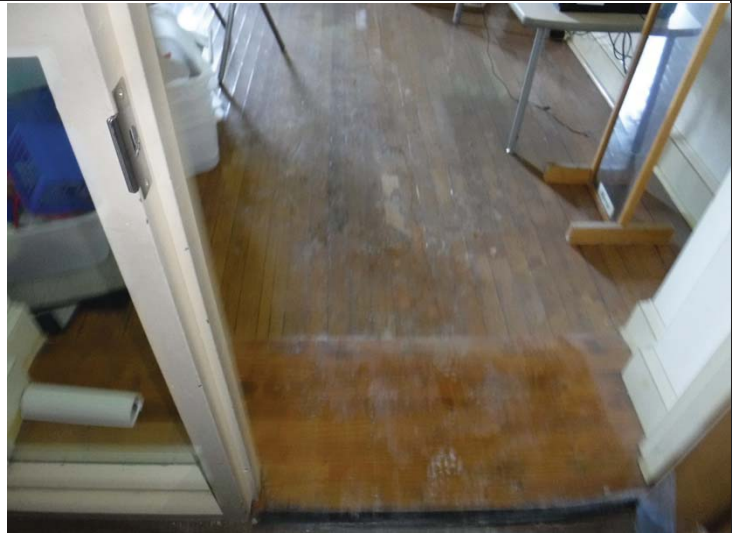
Caption #6: Floor condition at Classroom 307 and typical of wood floor condition at 3<sup>rd</sup> Floor Classrooms

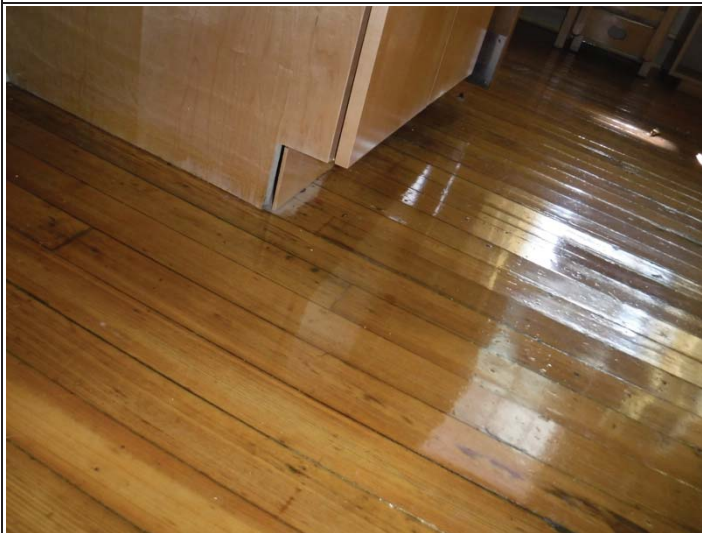
Caption #7: Classroom 306 toe kick condition at cabinets

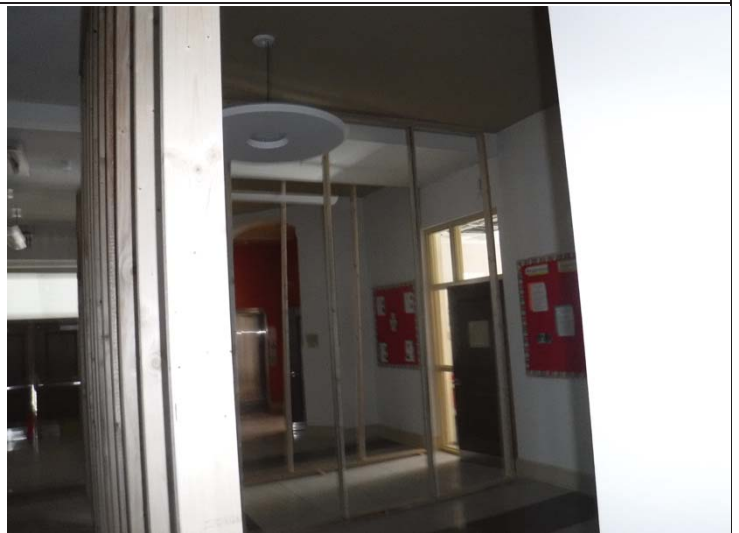
Caption #8: Temporary shoring installed at 2<sup>nd</sup> Floor Open Area/Hallway ceiling

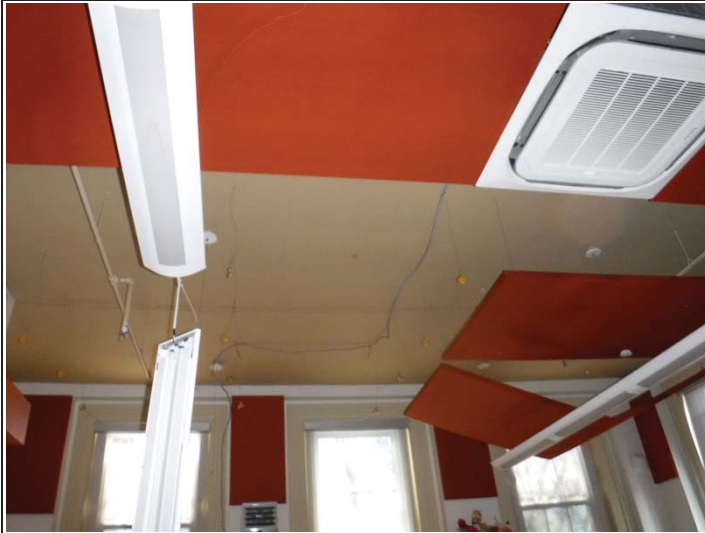
Caption #9: Classroom 206 damaged ceiling panels and light fixtures (typical at 2<sup>nd</sup> Floor Classrooms)

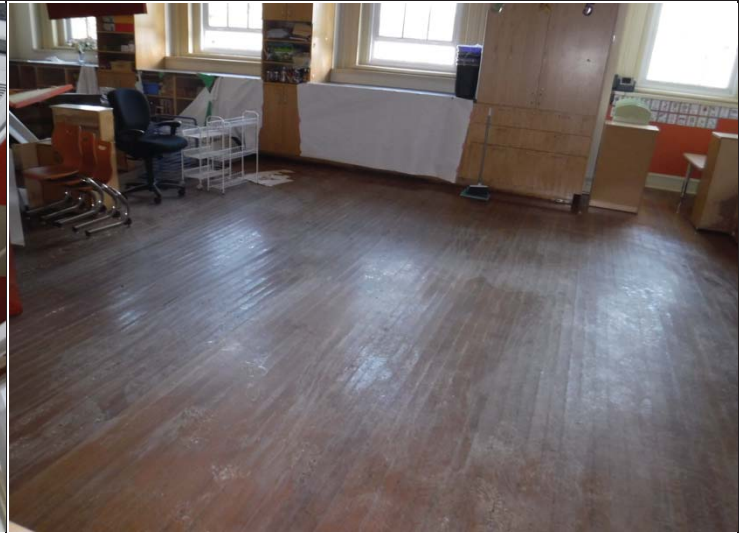
Caption #10: Classroom 203 condition at wood floors (typical at 2<sup>nd</sup> Floor Classrooms)

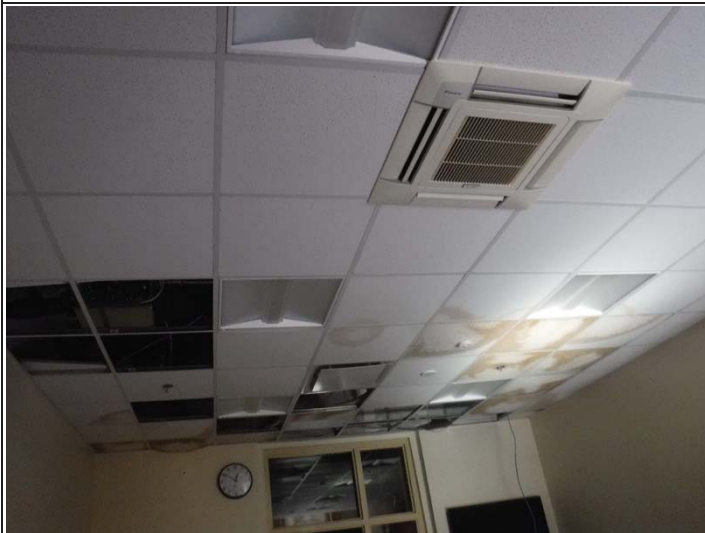
Caption #11: Ceiling condition at Staff Lounge -2<sup>nd</sup> Floor

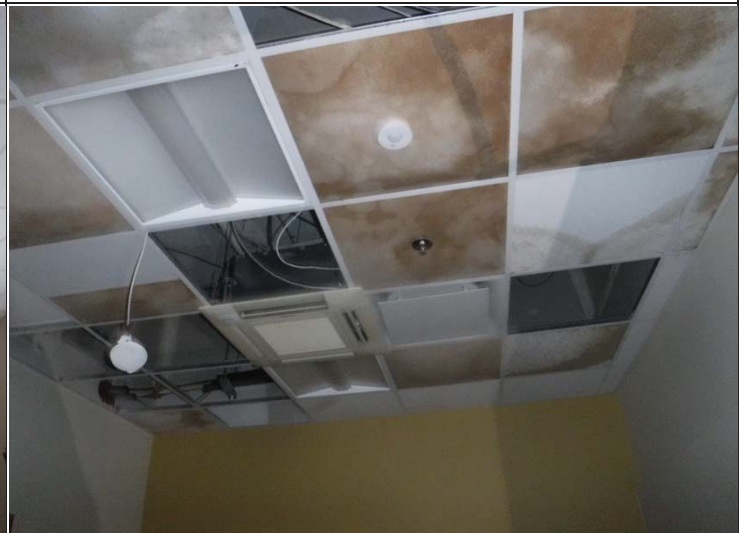
Caption #12: Conditions at Room 202 Social Worker ceiling

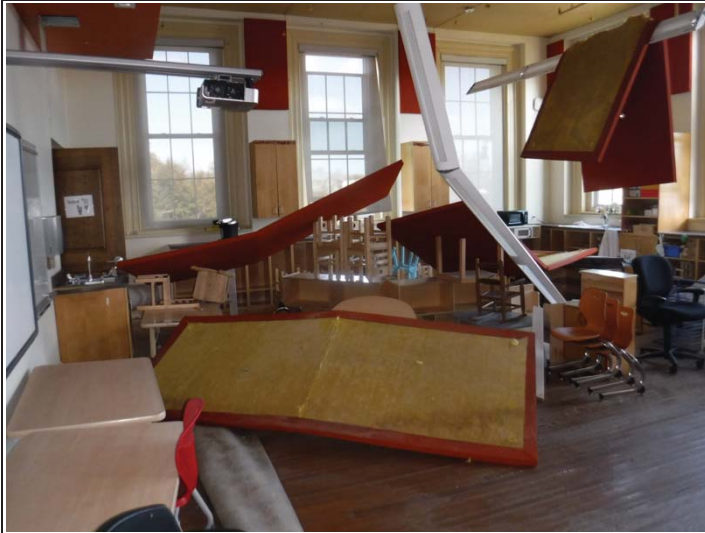
Caption #13: Classroom 203 damaged ceiling panels and lights – ( typical of 2<sup>nd</sup> floor Classrooms)

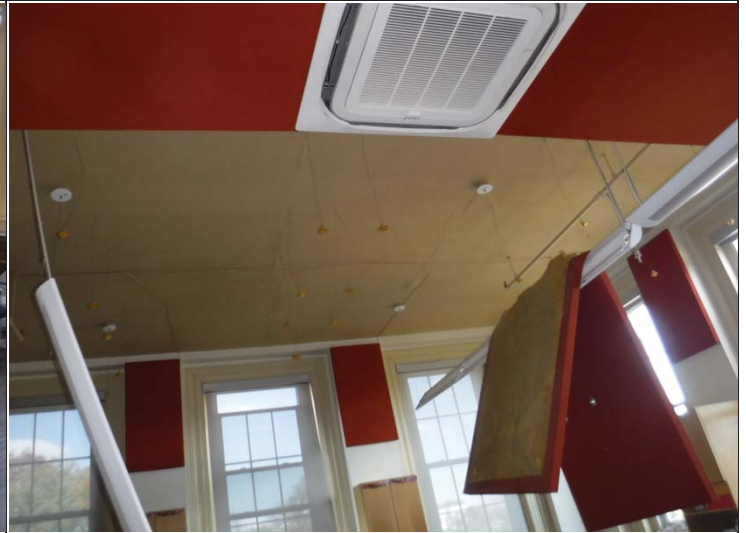
Caption #14: Damaged plaster ceilings – typical of 2<sup>nd</sup> Floor Classrooms

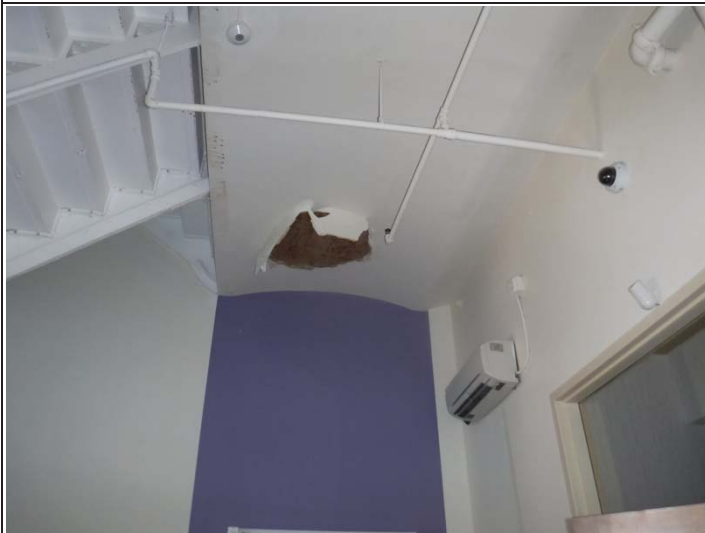
Caption #15: Damage at Level 1 Stairwell ceiling

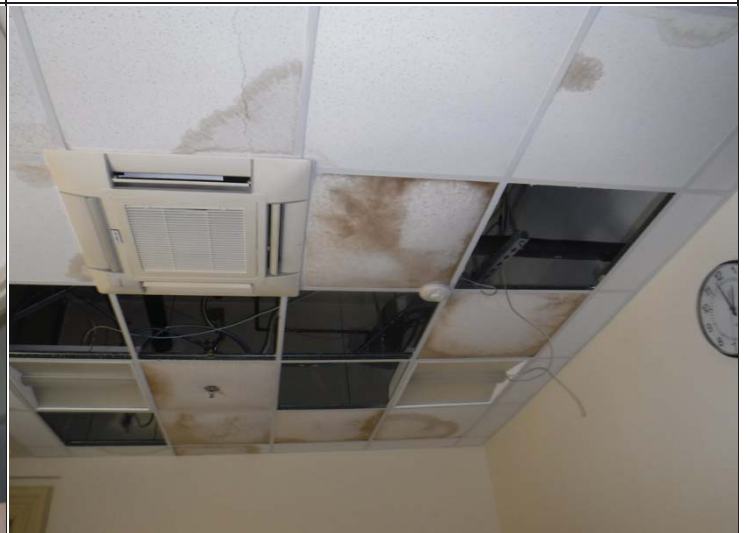
Caption #16: Condition at Principals Office 105B

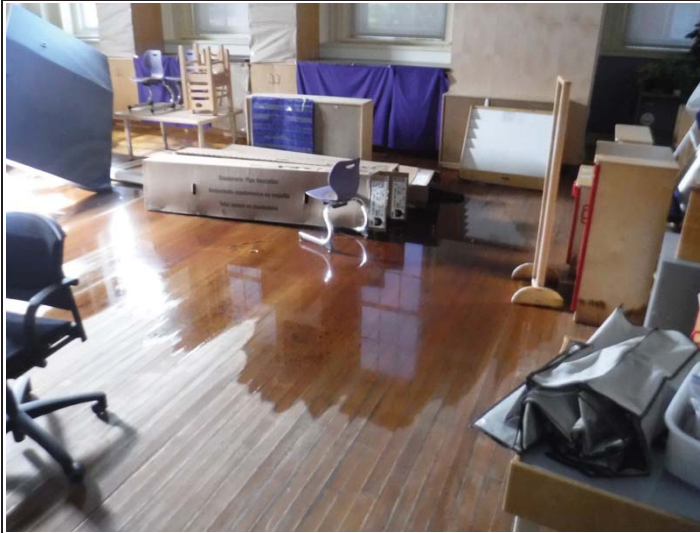
Caption #17: Classroom 106 Standing water

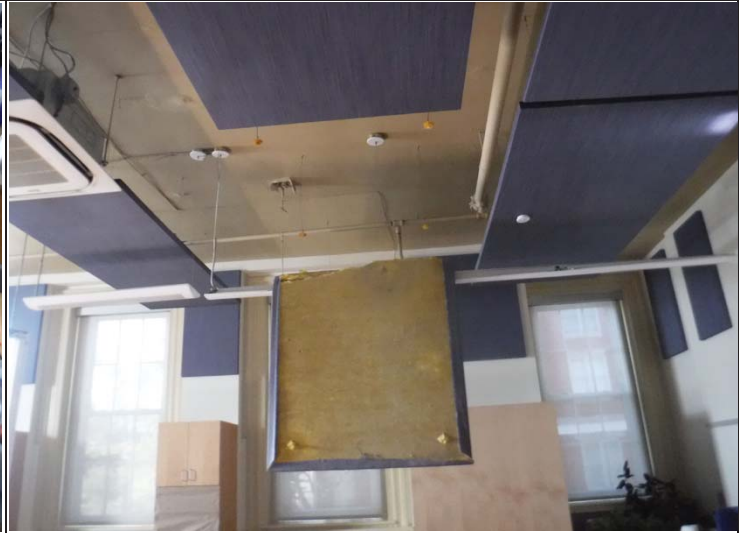
Caption #18: Classroom 106 damaged ceilings

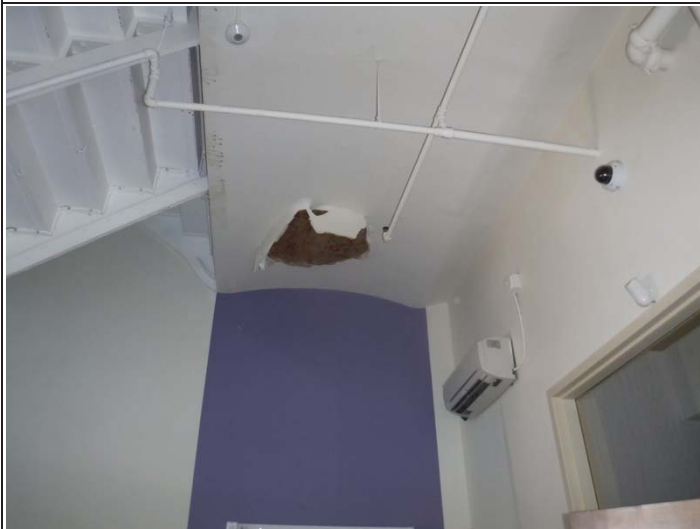
Caption #19: Damage at Level 1 Stairwell ceiling

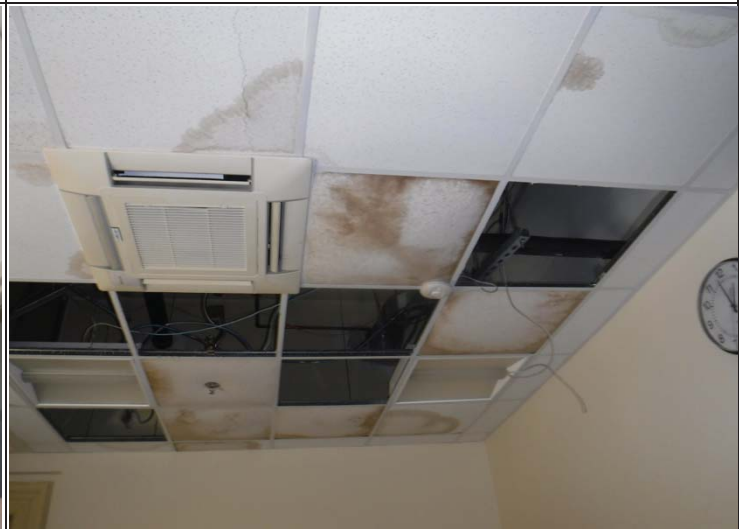
Caption #20: Condition at Principals Office 105B

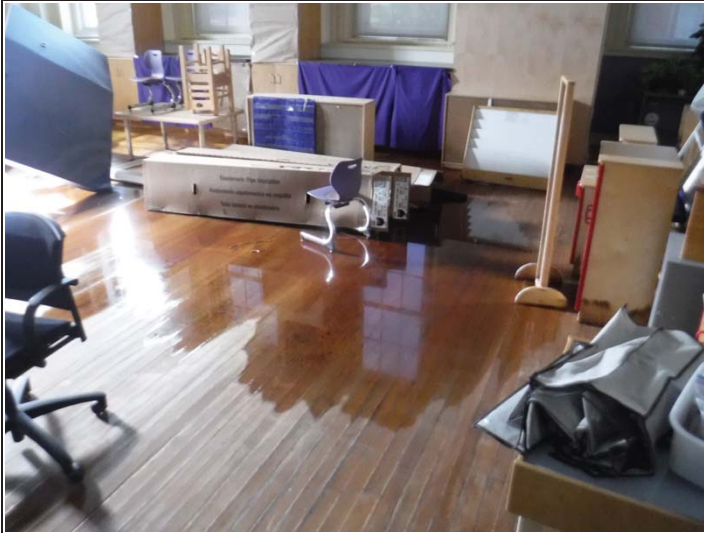
Caption #21: Classroom 106 Standing water

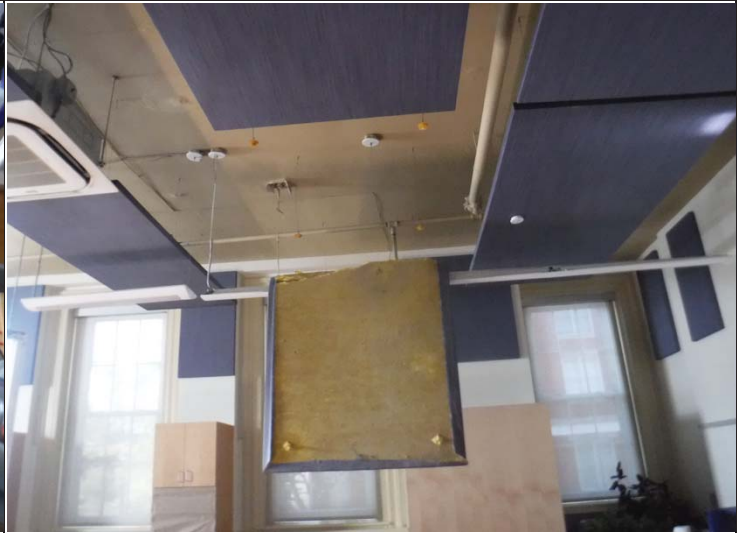
Caption #22: Classroom 106 damaged ceilings

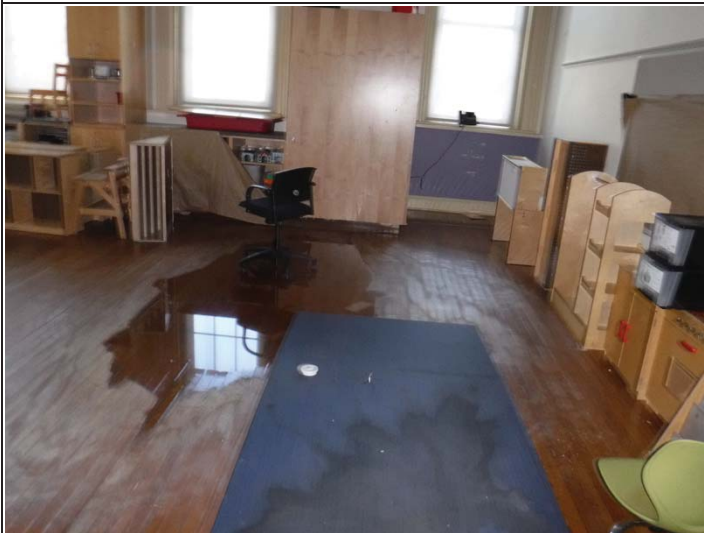
Caption #23: Classroom 107 Standing water

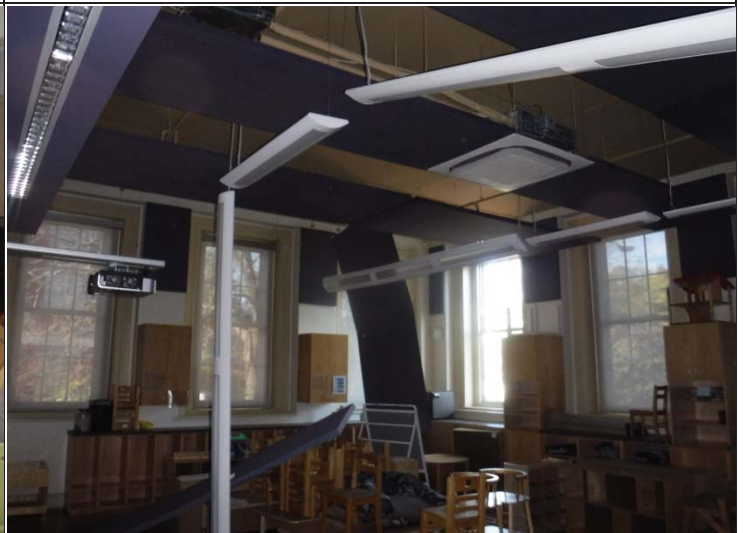
Caption #24: Classroom 107 damaged ceilings

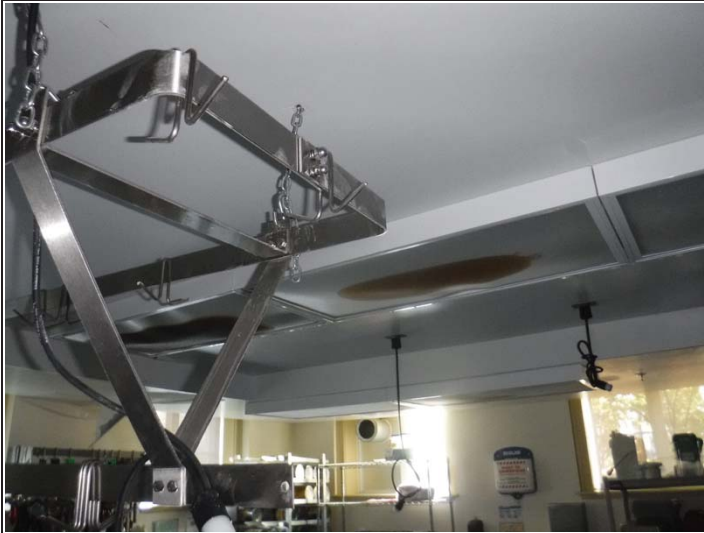
Caption #25: Kitchen 003 damaged ceiling and light fixtures

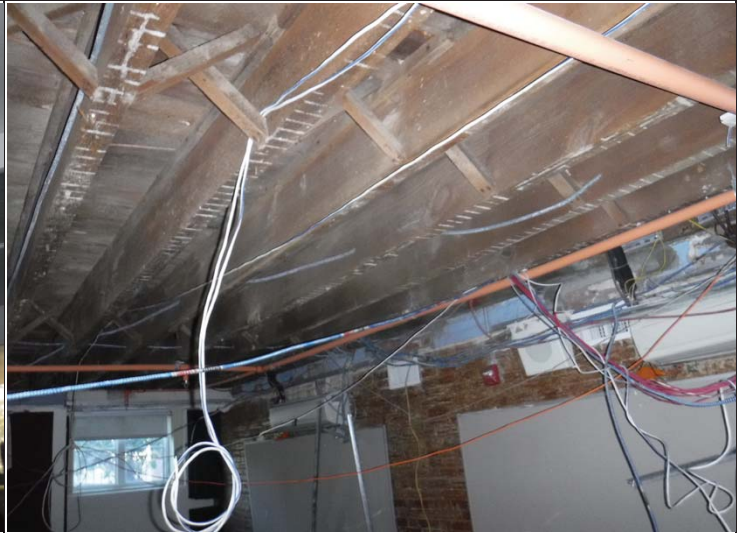
Caption #26: Basement area damaged ceiling

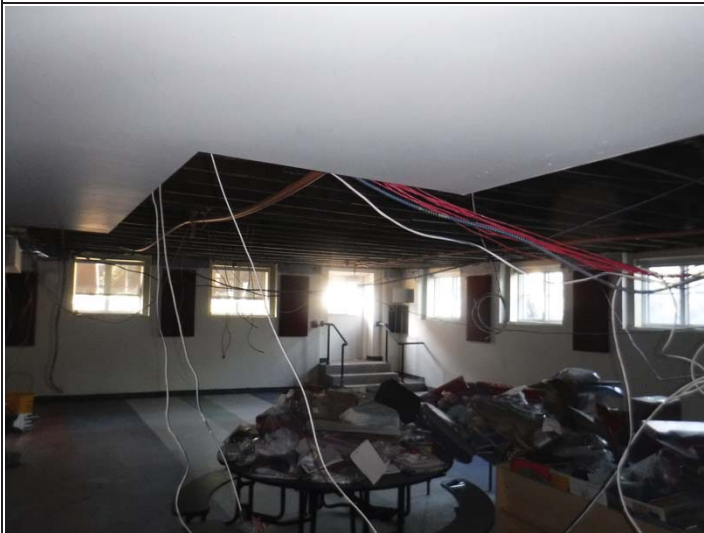
Caption #27: Cafeteria 010 Damaged Ceilings

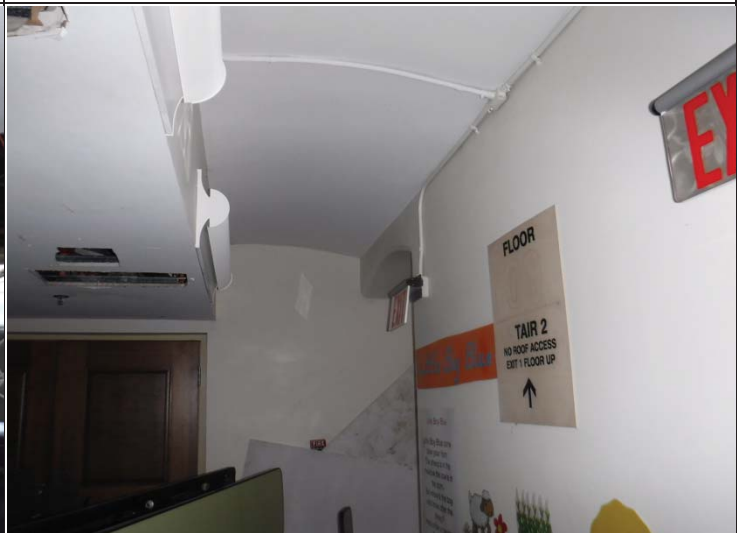
Caption #28: Basement area ceiling damaged
