**Re: Phase I Building Enclosure Investigation
Stuart-Hobson Middle School
Washington, DC
Walter P Moore Project No. D01.16016.00**

**STUART-HOBSON MIDDLE SCHOOL
PHASE I BUILDING ENCLOSURE
INVESTIGATION**

401 E St NE
Washington, DC 20002

Report Date	September 29, 2016
Façade System (Auditorium)	Brick Mass Wall
WPM Project No.	D01.16016.00

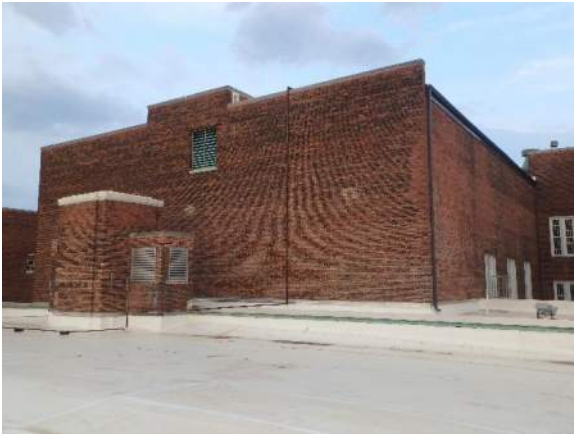
Photo 1: Overall view of north and west exterior walls of auditorium.

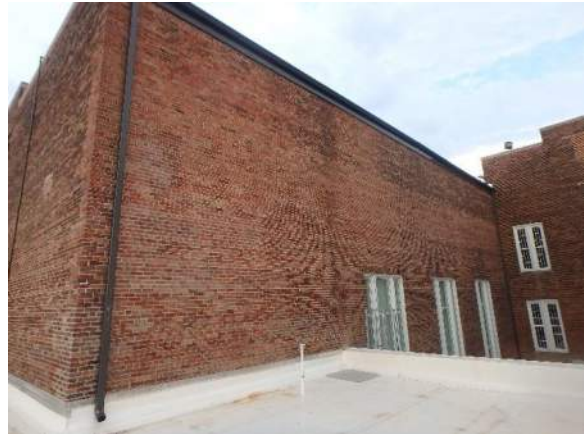
Photo 2: General view of west exterior wall of auditorium.

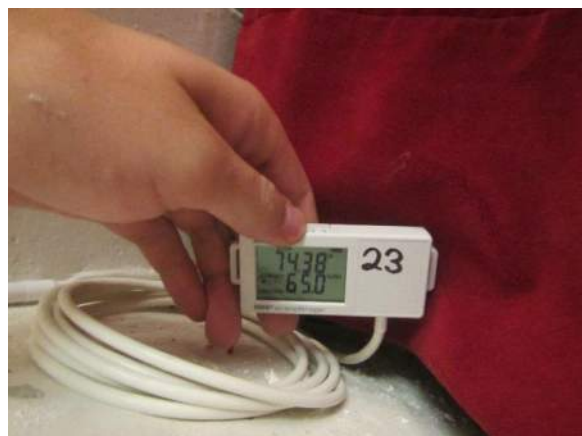
Walter P Moore set twelve data loggers at the east and west walls inside the auditorium (Photo 24). Data logger probes were set at the following typical locations. Refer to the referenced data logger images in Exhibits C and D for representative installations.

Photo 24: Datalogger set at window sill.

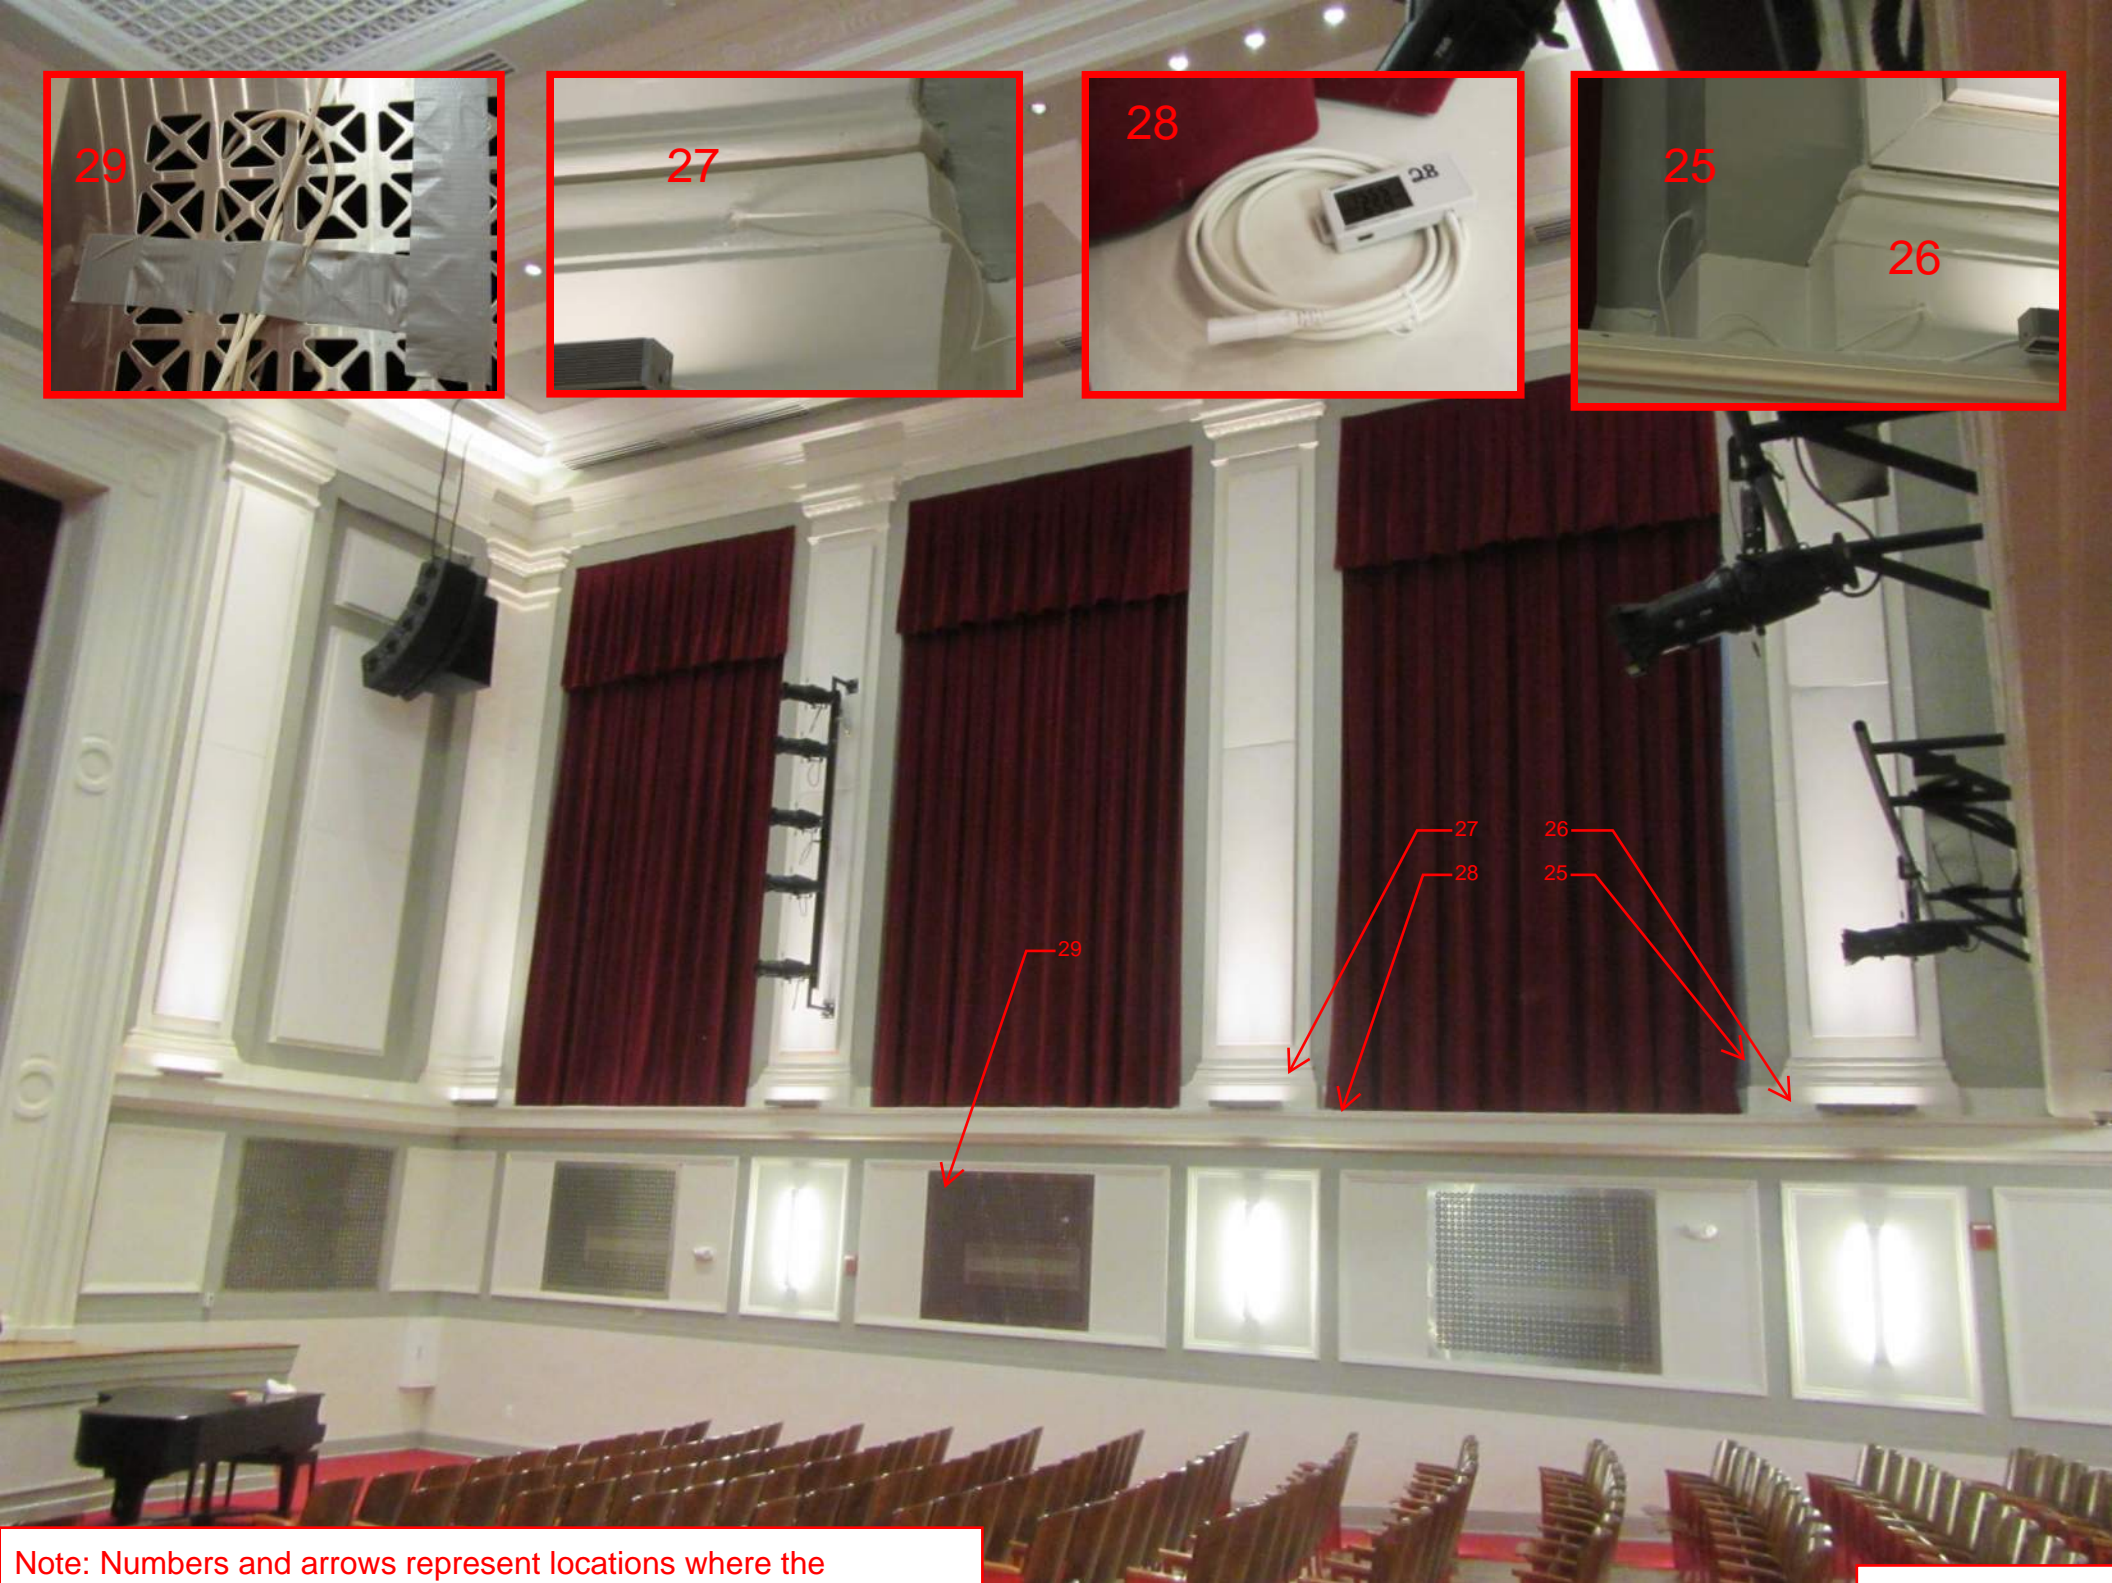
Note: Numbers and arrows represent locations where the corresponding data loggers were placed at east wall of auditorium.

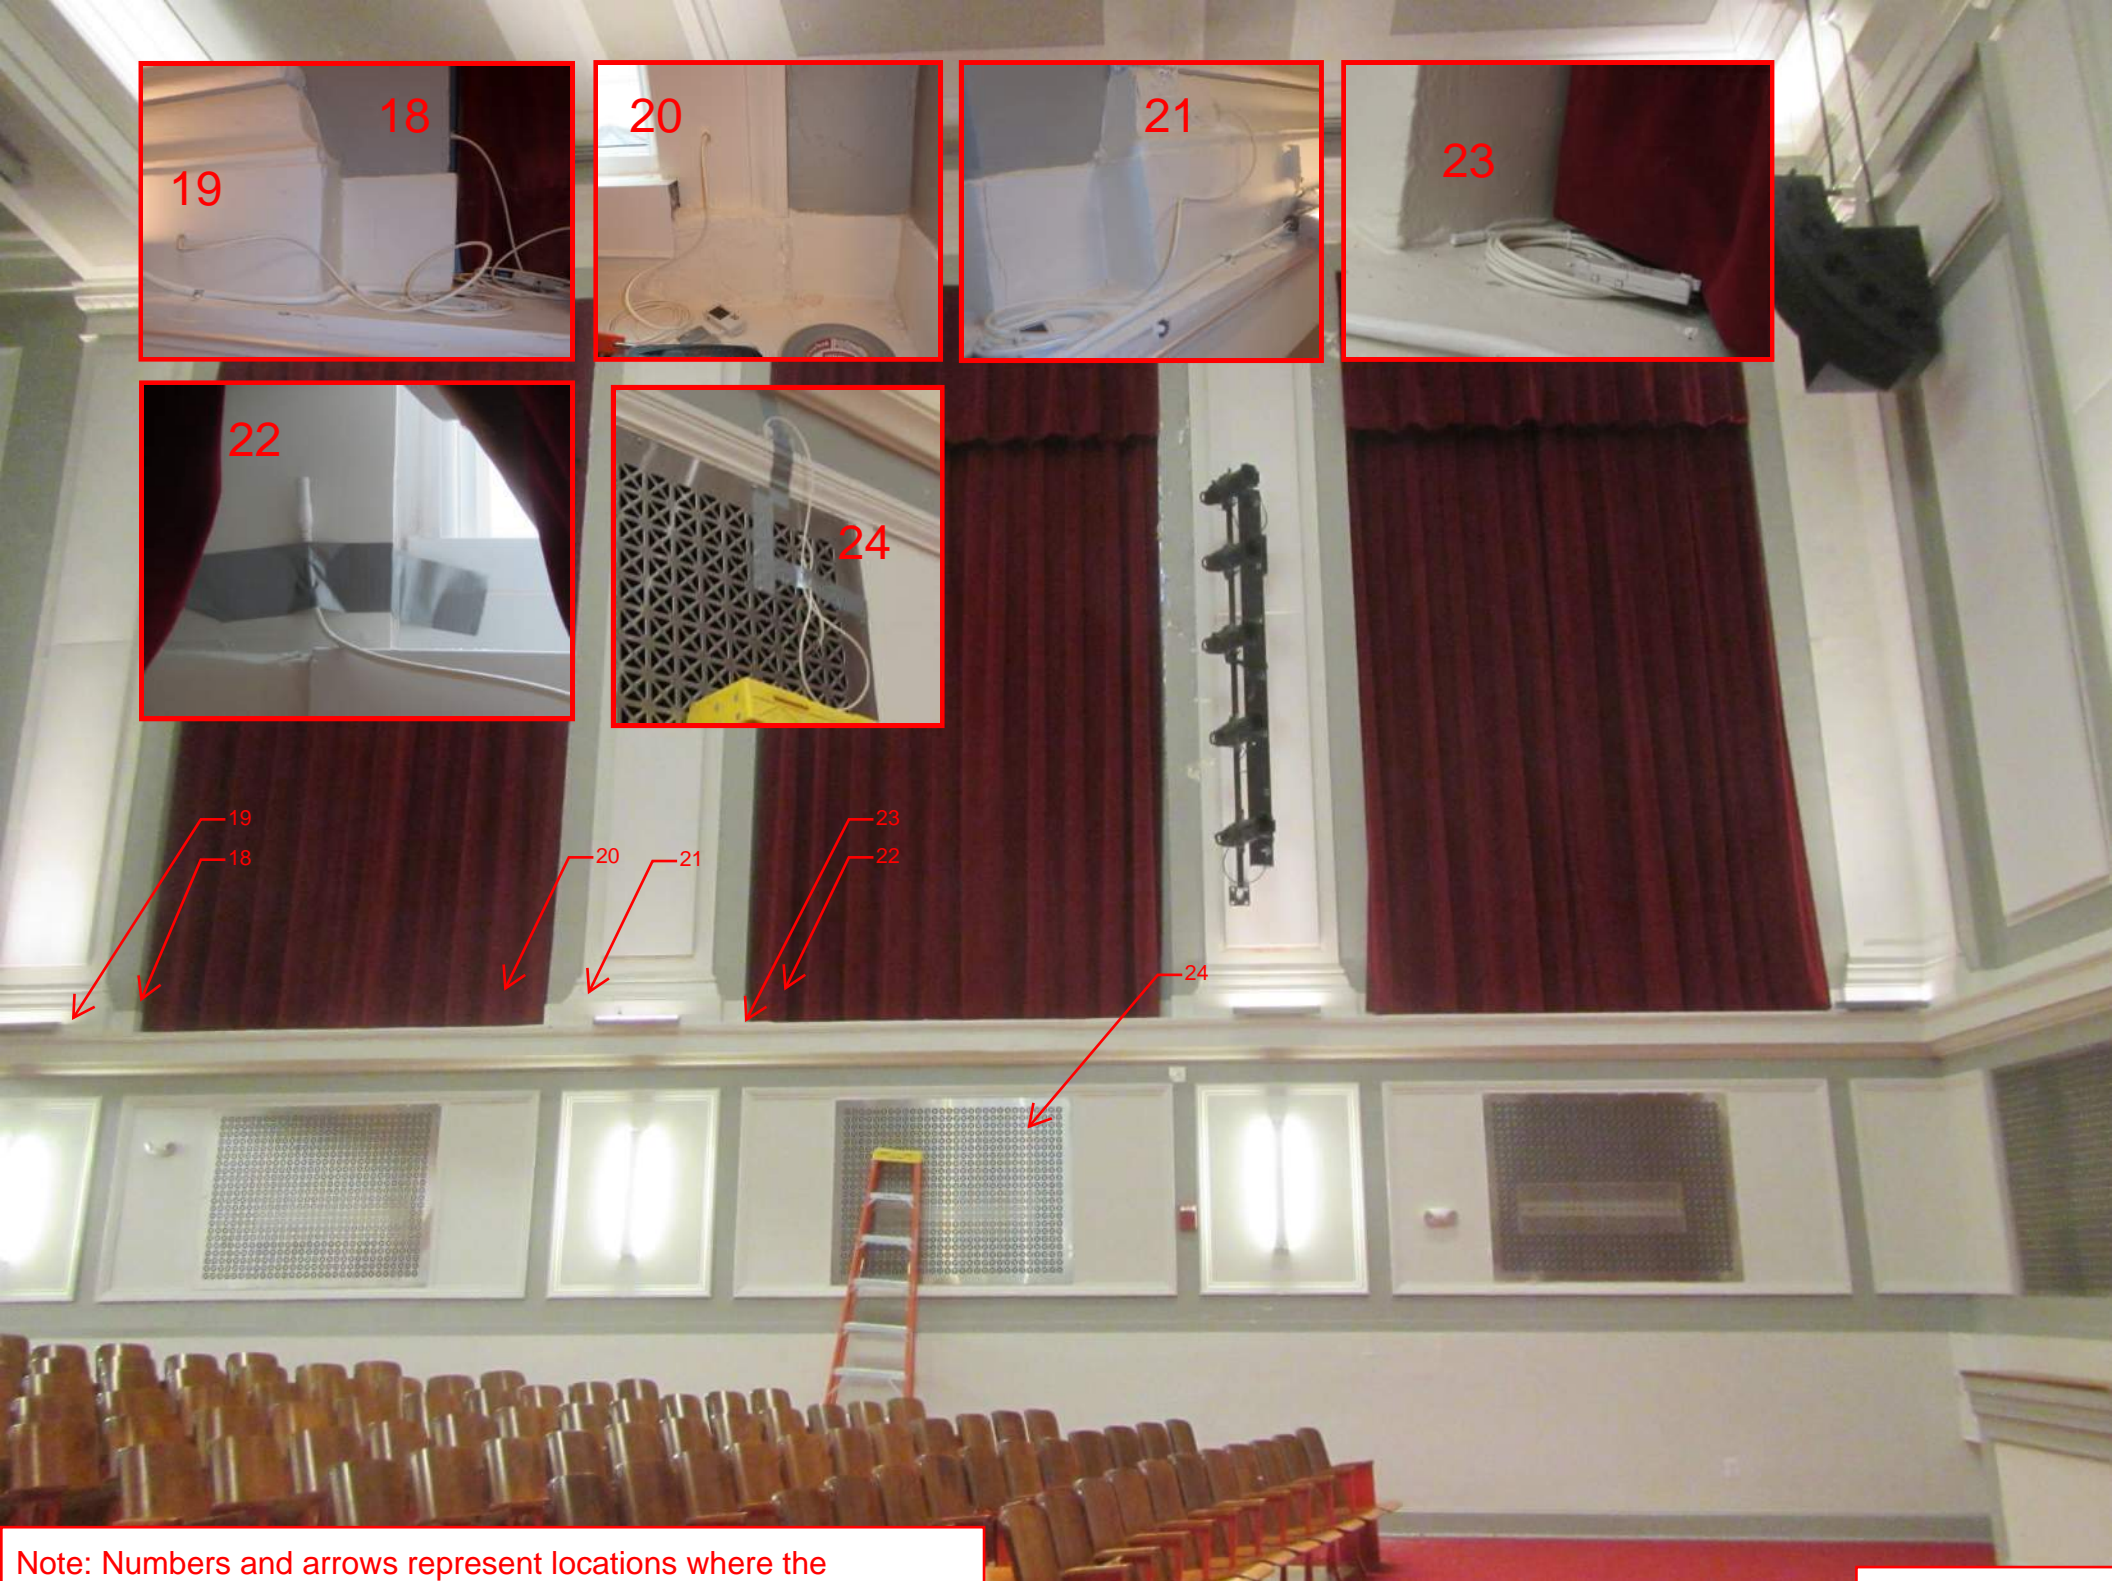
Note: Numbers and arrows represent locations where the corresponding data loggers were placed at west wall of auditorium.
